# Aerial Tree Survey

Prepared on the 1st of March 2020 for

# Climbing Inspection Form

### 2.1 T1 - Common Beech (*Fagus sylvatica*)

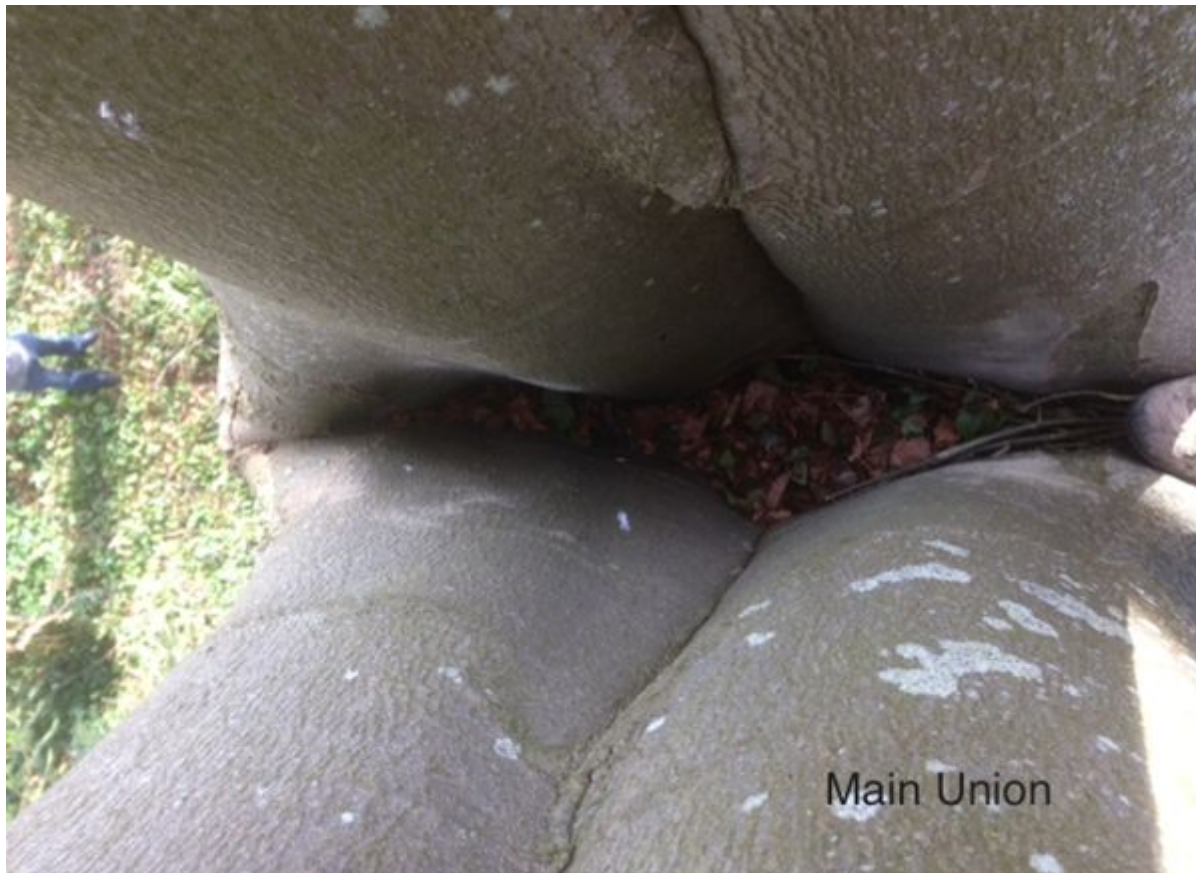
## Appendix 1

- T1 has a Large included union approximately 8-10m high (apex 1), above this union is a large mature canopy distributed between the two stems.
- Whilst conducting the climbing inspection I prodded the inside of the union with a metal device to see depth of cavity, however this was inconclusive as I was unable to touch any sound wood with the tip of the probe. This is clear evidence that the cavity is of large deep proportion.

T1 showing union in question

In my opinion the felling of the T1 to ground level is the viable, practical and safe option.

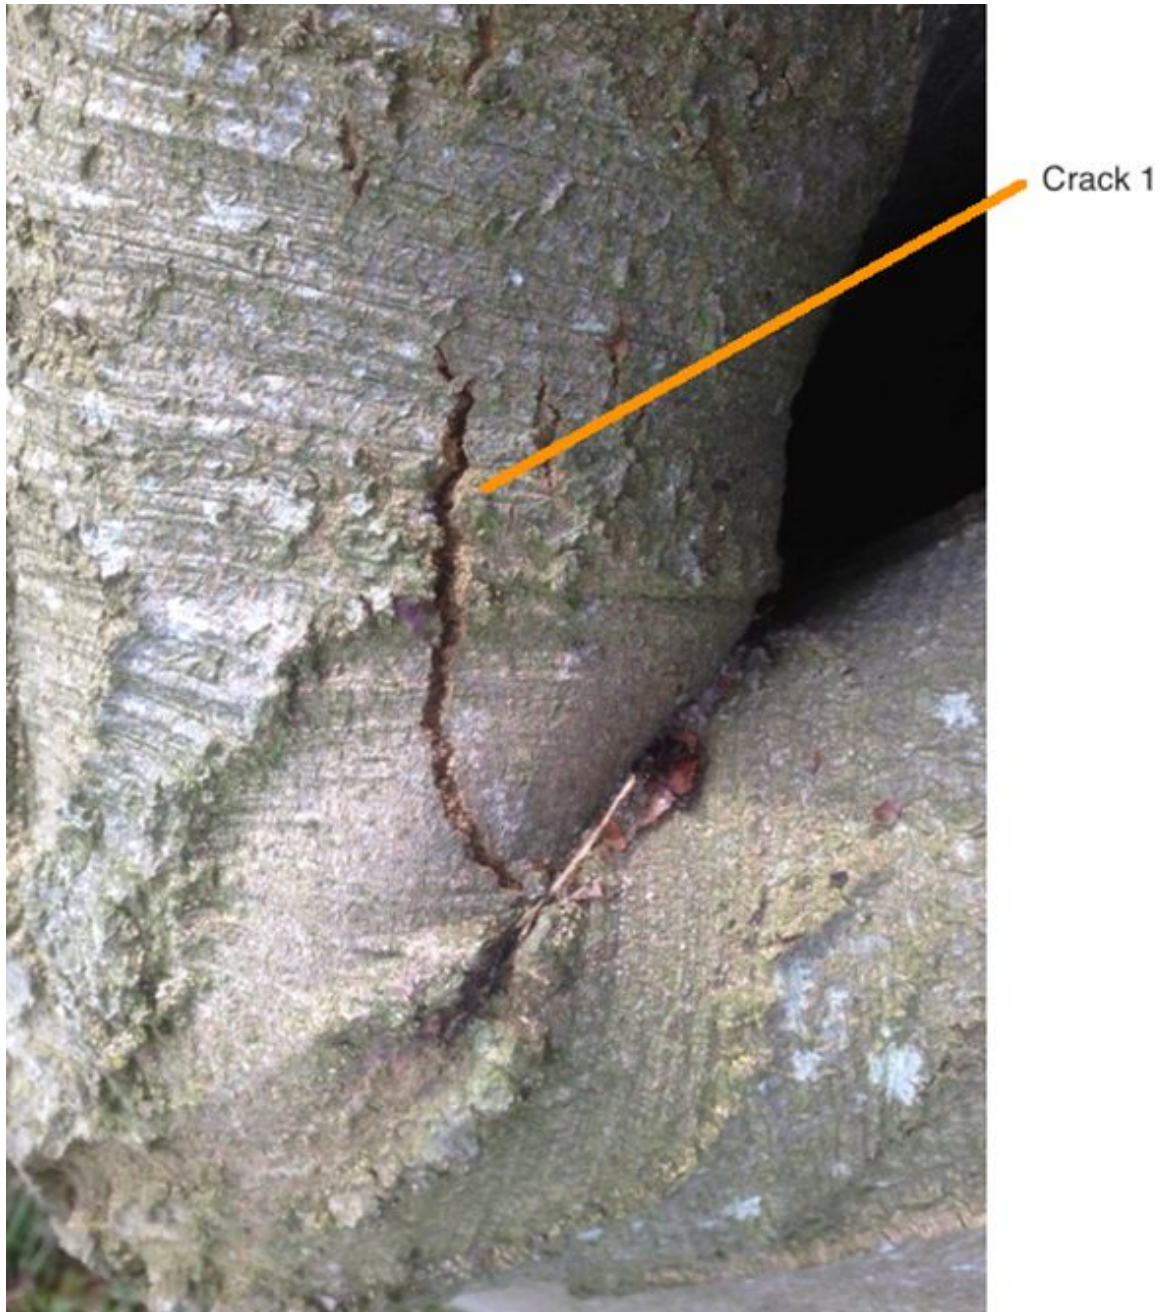
## Appendix 2A

- There are clear signs of recent cracks on the union (apex 2 A and B) making it clear that there is an unhealthy proportion of movement within the union

- The rounded rib is more Likely to fail due to the depth of the cavity along with the sink area on the stem and the recent sign of 2 cracks in the bark due to the movement/stress on the union.

Image showing 2x crack on union

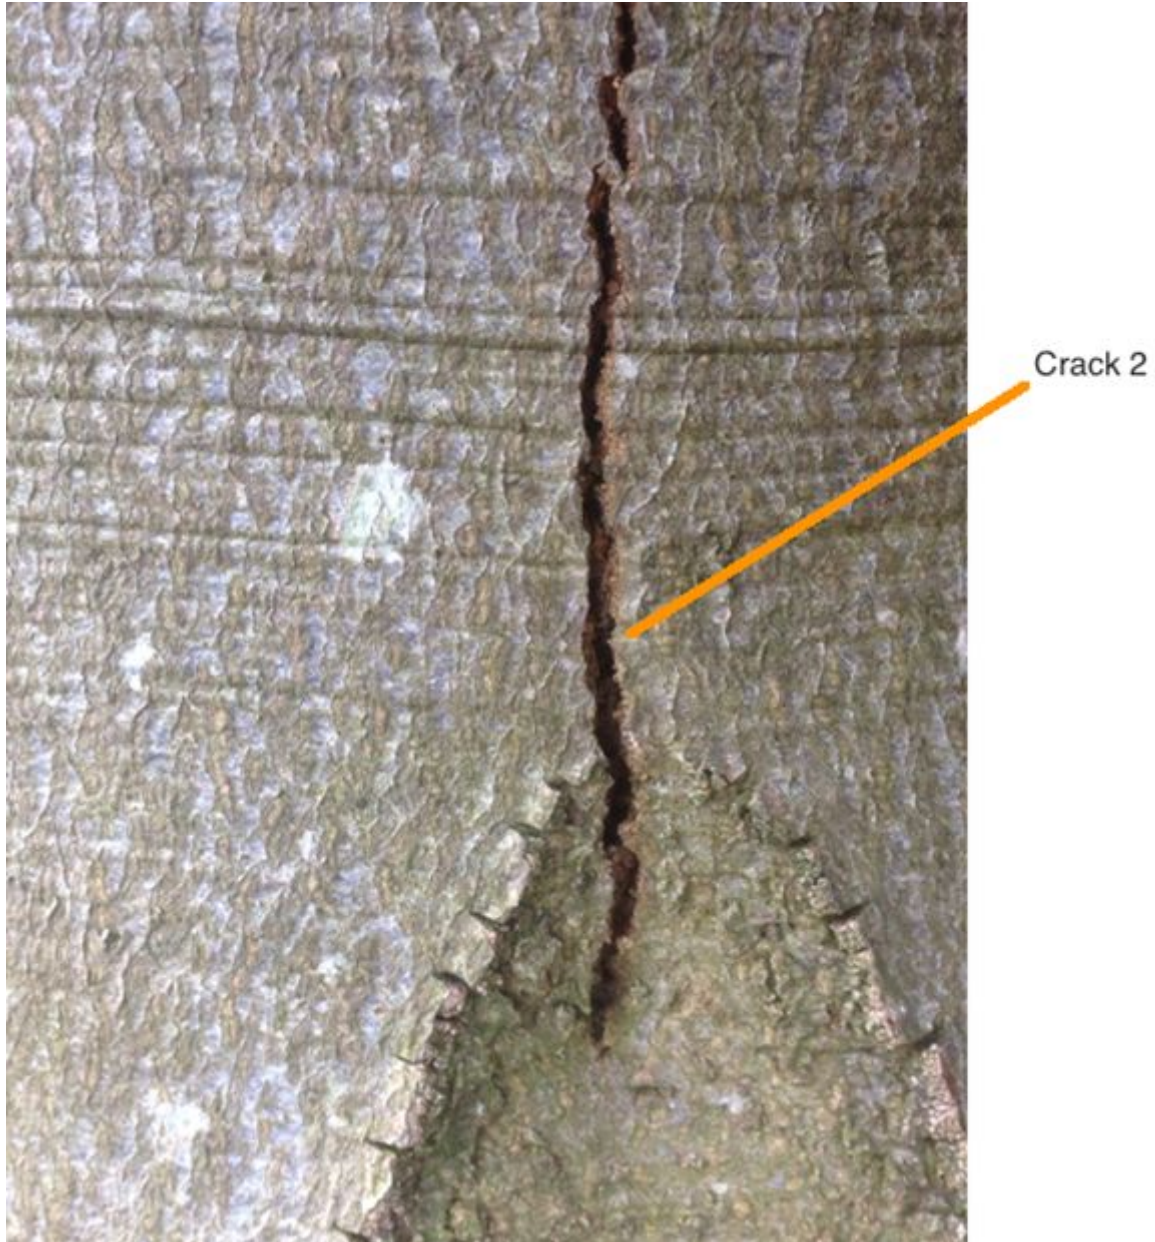
## Appendix 2B

Image showing 2x crack on union

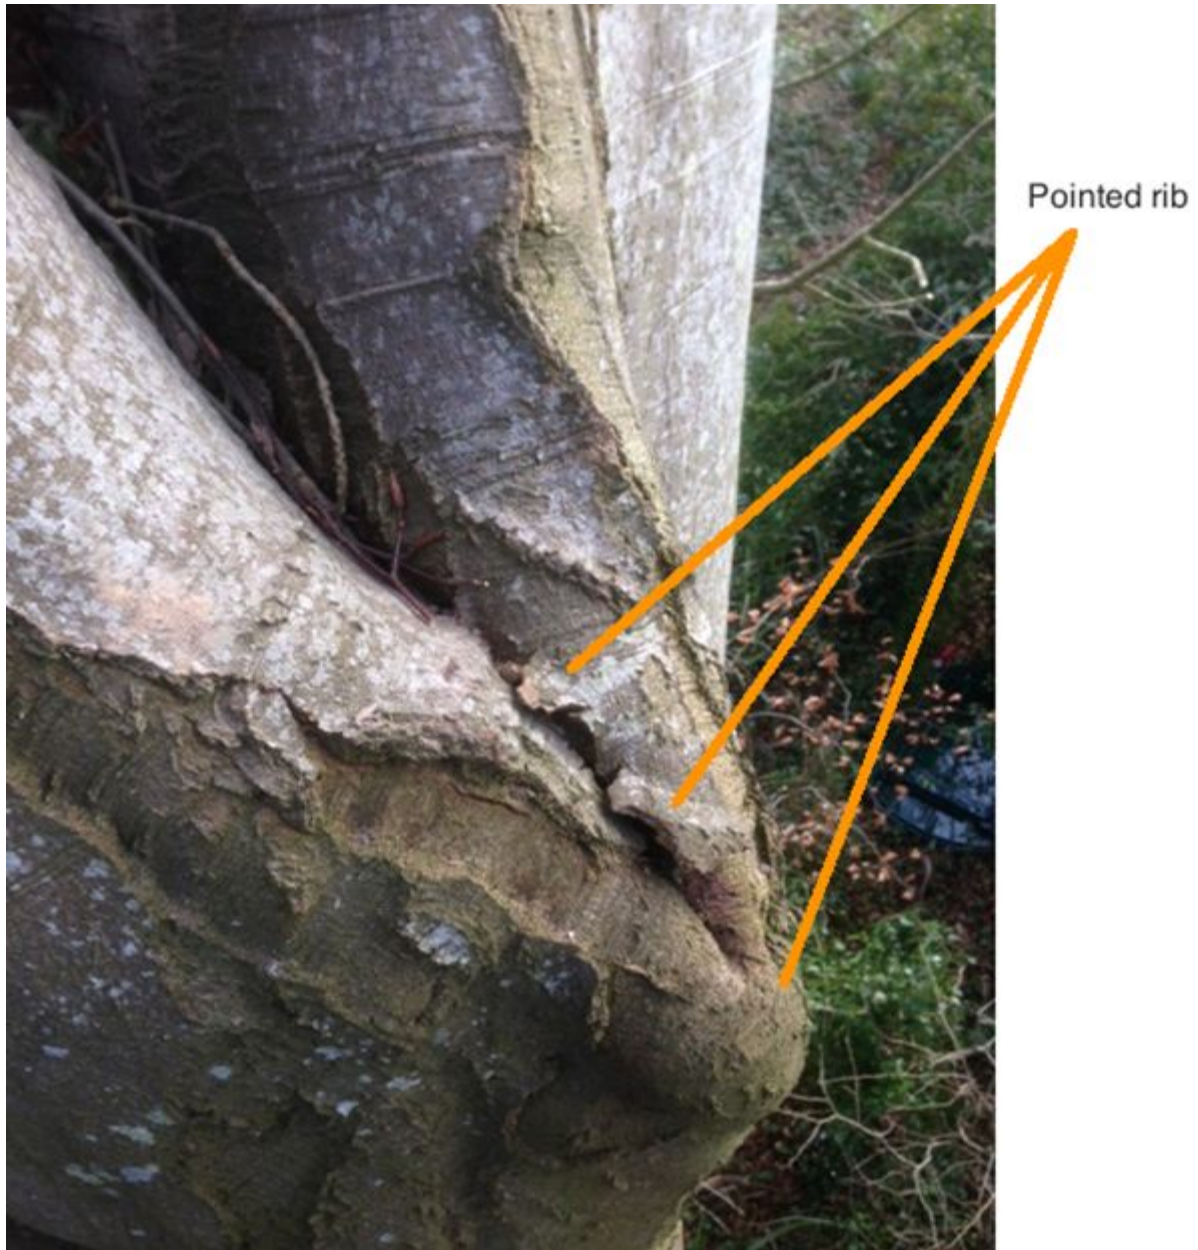
## Appendix 3

- Located on the union is one pointed rib (apex 3) and another rounded rib (apex 4)
- Located on the side of the tree where the rounded rib is, of which side also holds the cracks is a sinked area of the stem (apex 5) which is a sign of minimal holding wood showing us that the cavity in-between the two stems has pockets internally within the union that are a potential weak point for the tree increasing the likelihood of failure.

Image showing pointed rib

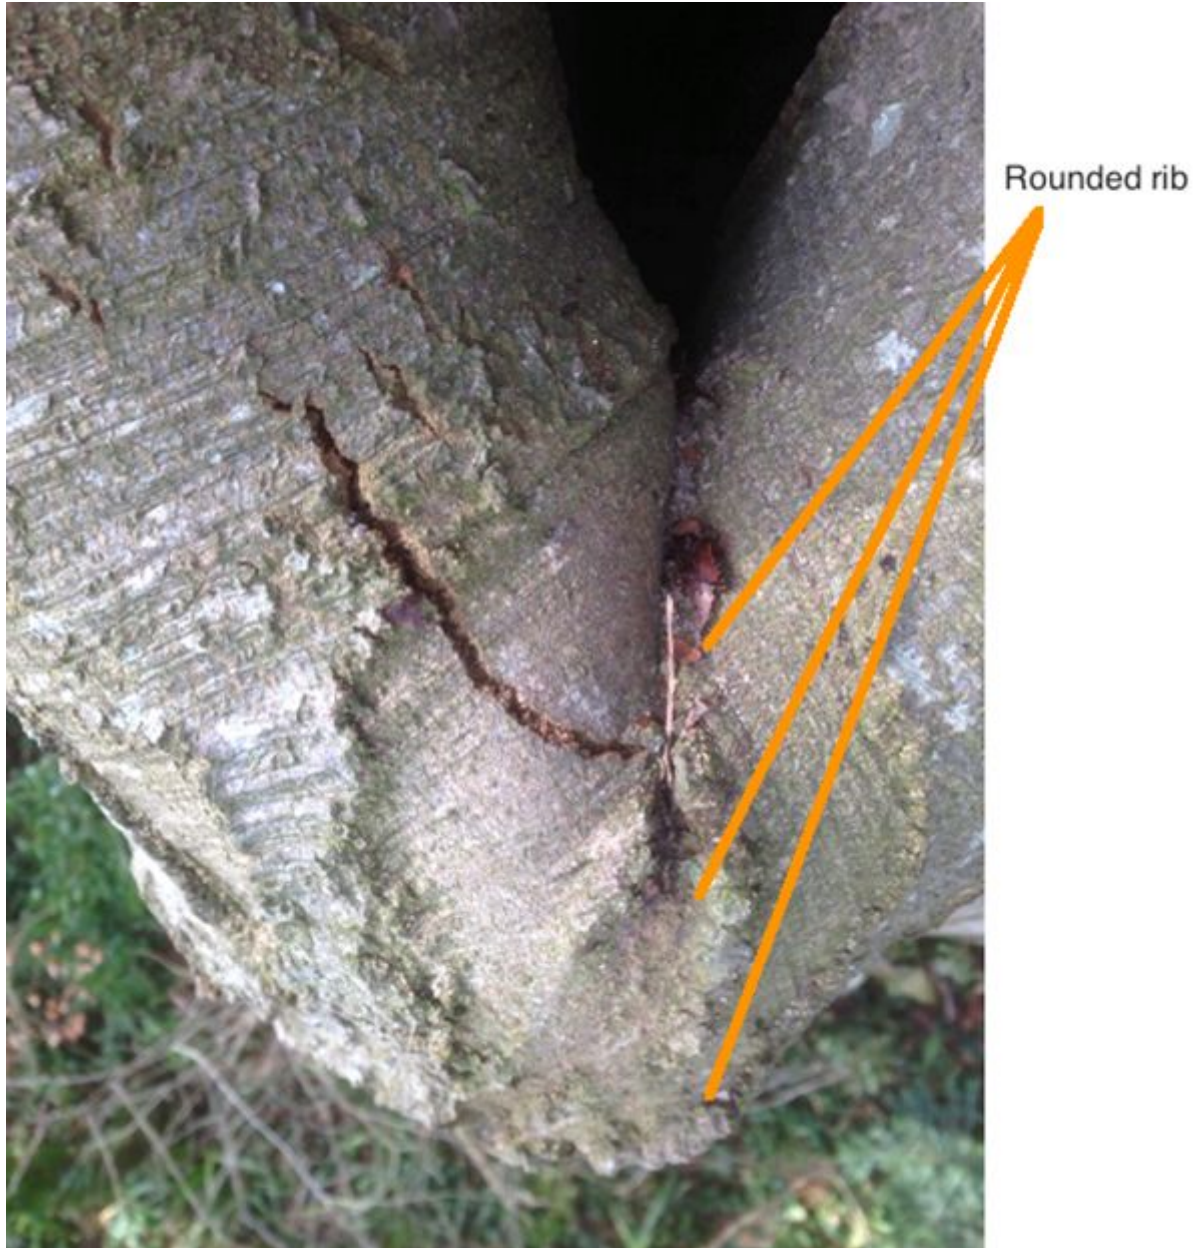
## Appendix 4

Image showing rounded rib

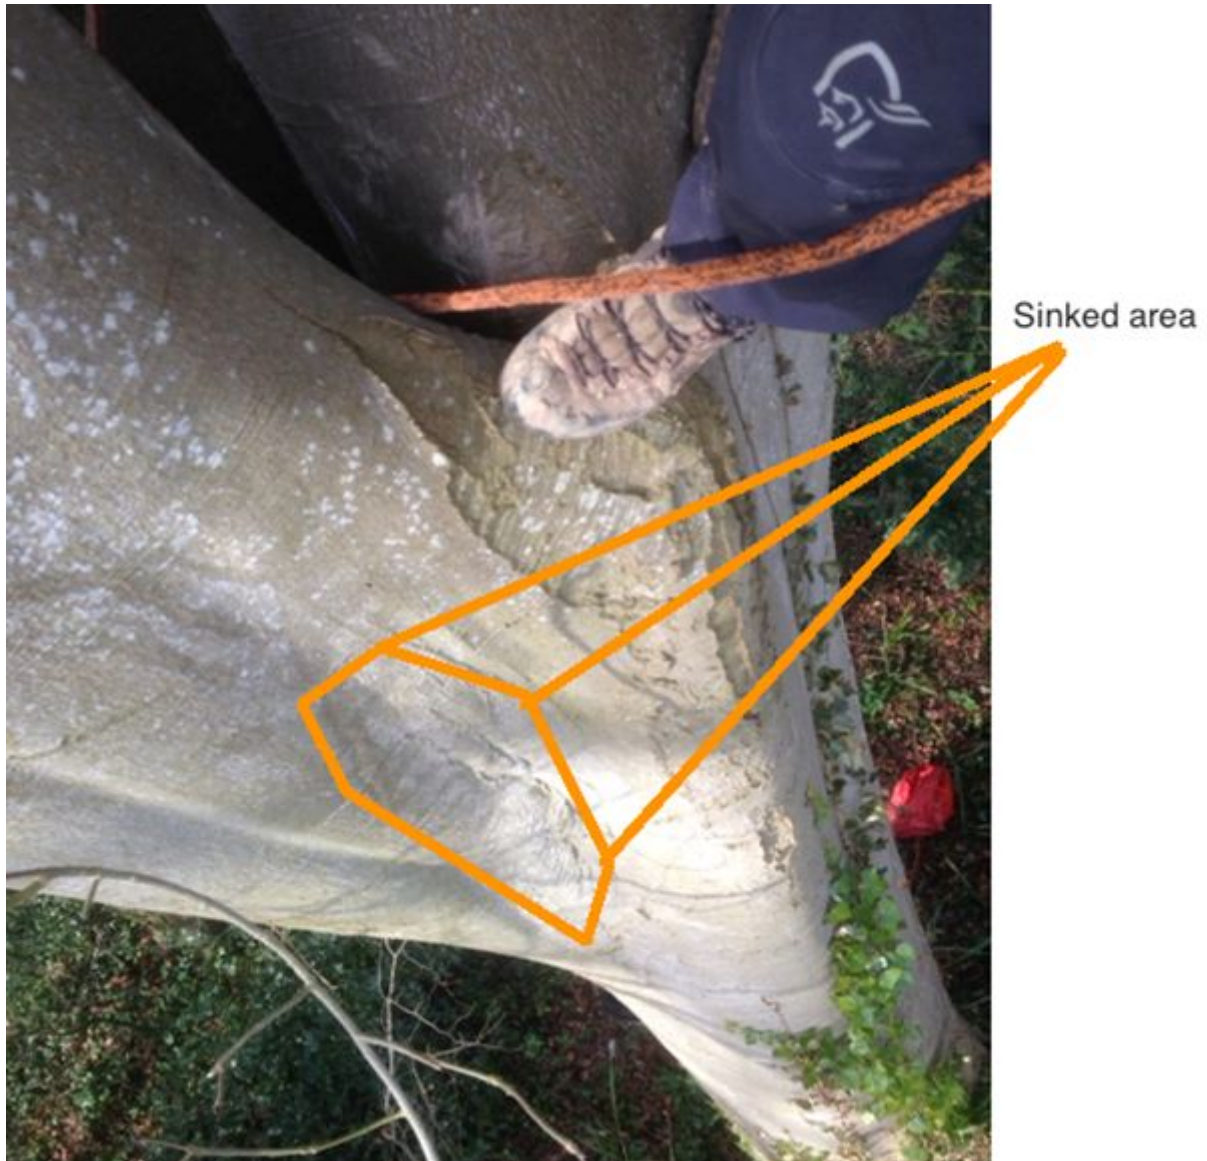
## Appendix 5

Image showing sunken area on stem

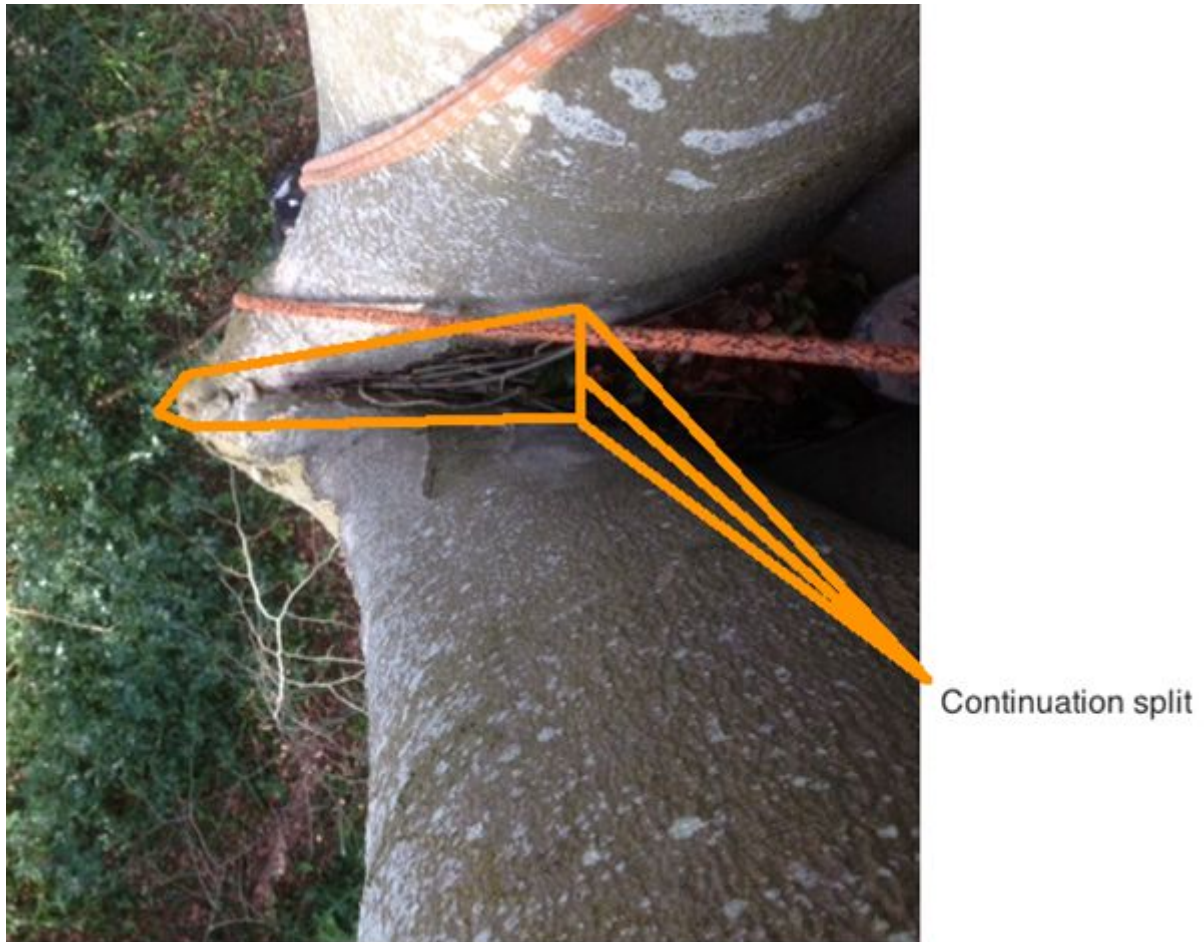
## Appendix 6

- On the side of the tree with the pointed rib there is a clear continuation of the split (apex 6) carrying on past holding wood indicating that the union will carry on with movement causing the crotch to further strain itself with more stress.

Image showing pointed rib with continuation split

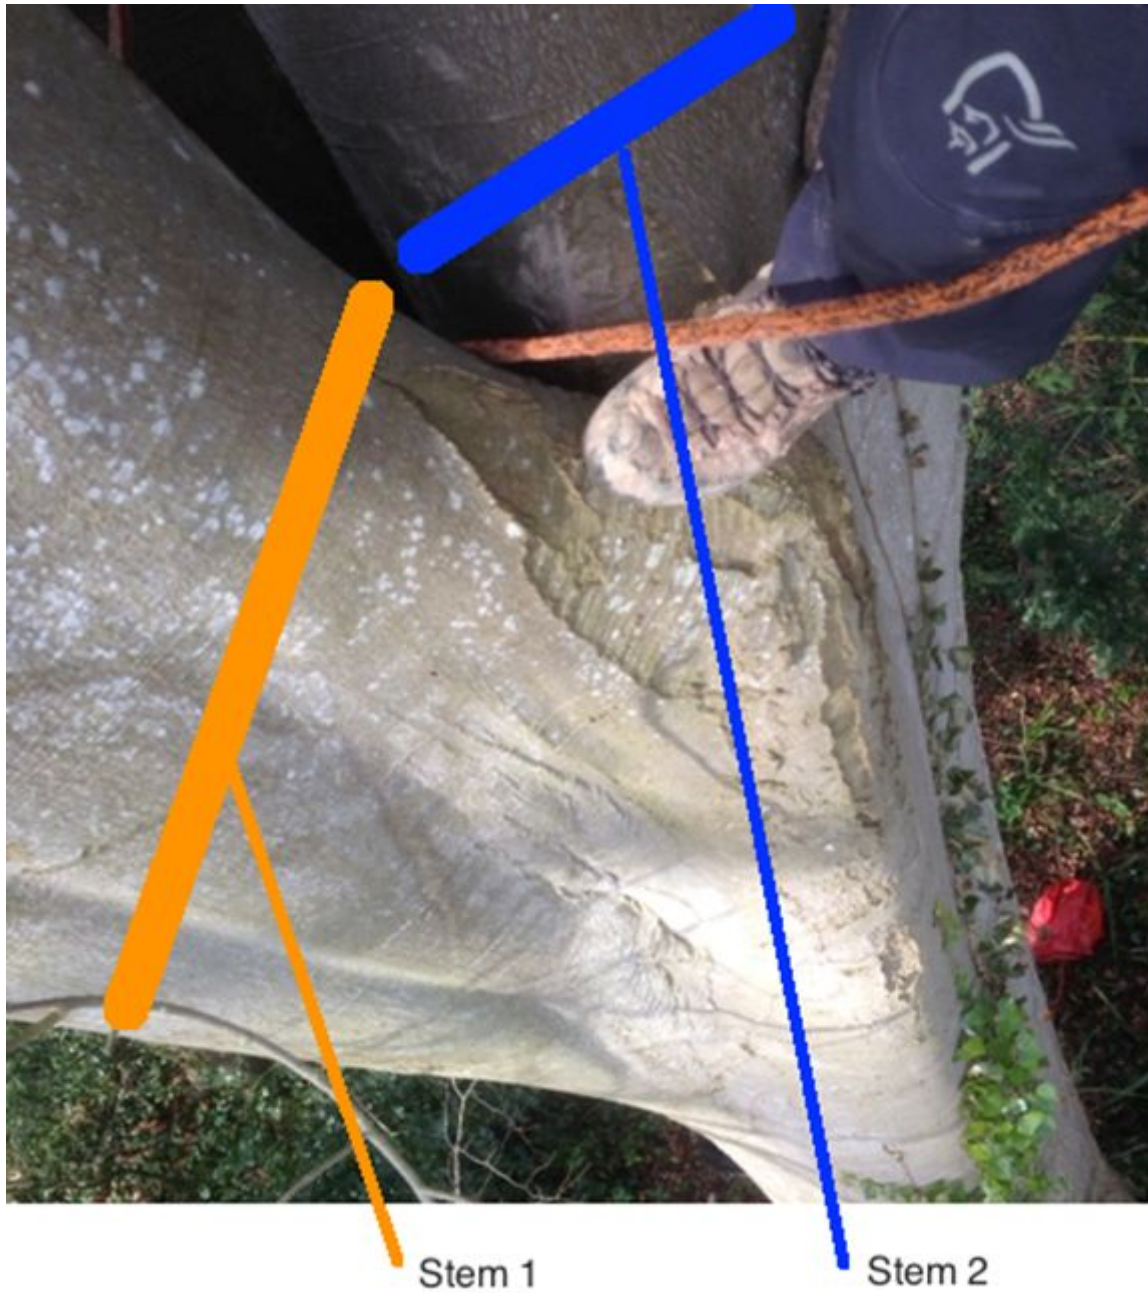
## Appendix 7

- If the tree did fail it is my opinion that stem 1 (apex 7) would initially fail first, falling in-between the fence and the public pathway, there is a possibility that stem 1 could reach the public footpath and may cause significant damage to the fence depending on the direction of failure.

Showing stem 1 and stem 2 from union
