Tree Survey

Prepared on the 1st of March 2020 for

Tree	Species	Age Class	Height	Photos
T1	Common Beach (<i>Fagus sylvatica</i>)	Mature	15m	Yes

2.1 T1 - Common Beech (*Fagus sylvatica*)

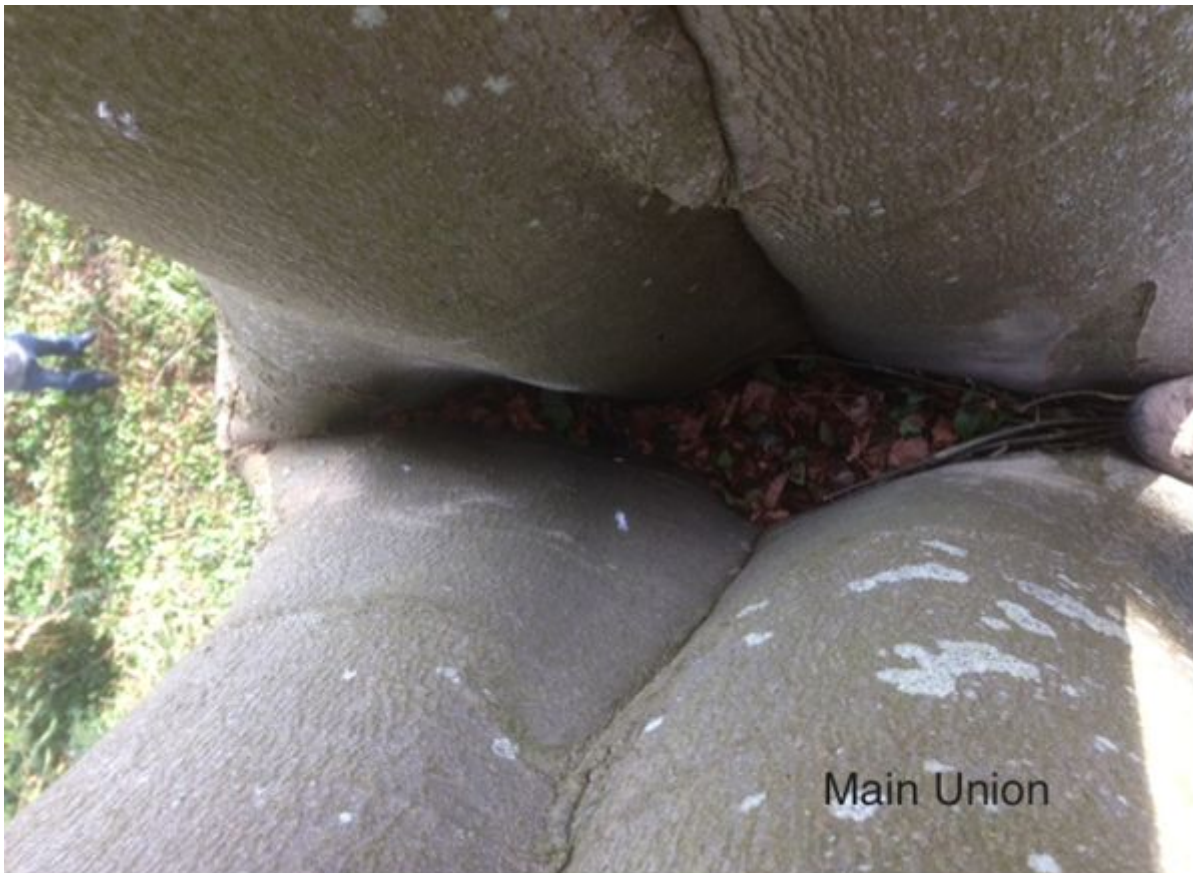
Appendix 1

- T1 has a Large included union approximately 8-10m high (apex 1), above this union is a large mature canopy distributed between the two stems.
- Whilst conducting the climbing inspection I prodded the inside of the union with a metal device to see depth of cavity, however this was inconclusive as I was unable to touch any sound wood with the tip of the probe. This is clear evidence that the cavity is of large deep proportion.

T1 showing union in question

In my opinion the felling of the T1 to ground level is the viable, practical and safe option.

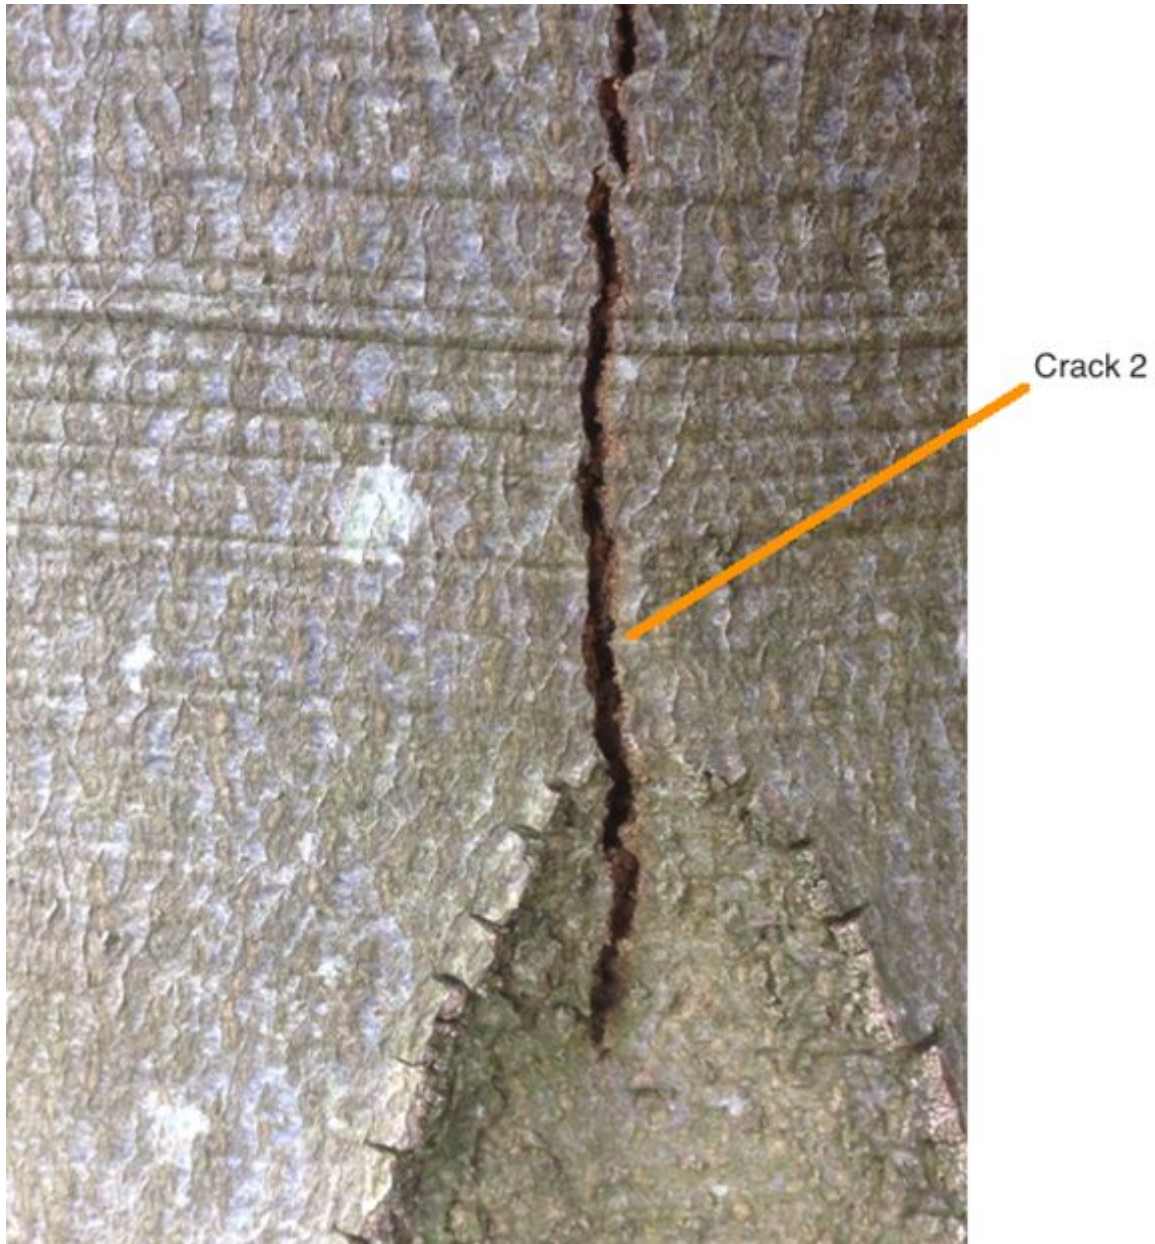
Appendix 2B

- There are clear signs of recent cracks on the union (apex 2 A and B) making it clear that there is an unhealthy proportion of movement within the union

- The rounded rib is more Likely to fail due to the depth of the cavity along with the sink area on the stem and the recent sign of 2 cracks in the bark due to the movement/stress on the union.

- It is my opinion that this tree has significant risk factor of which is evident in (apex 2A and B) (apex 5) (apex 6)
- The tree is approximately 110 years of age

Image showing 2x crack on union

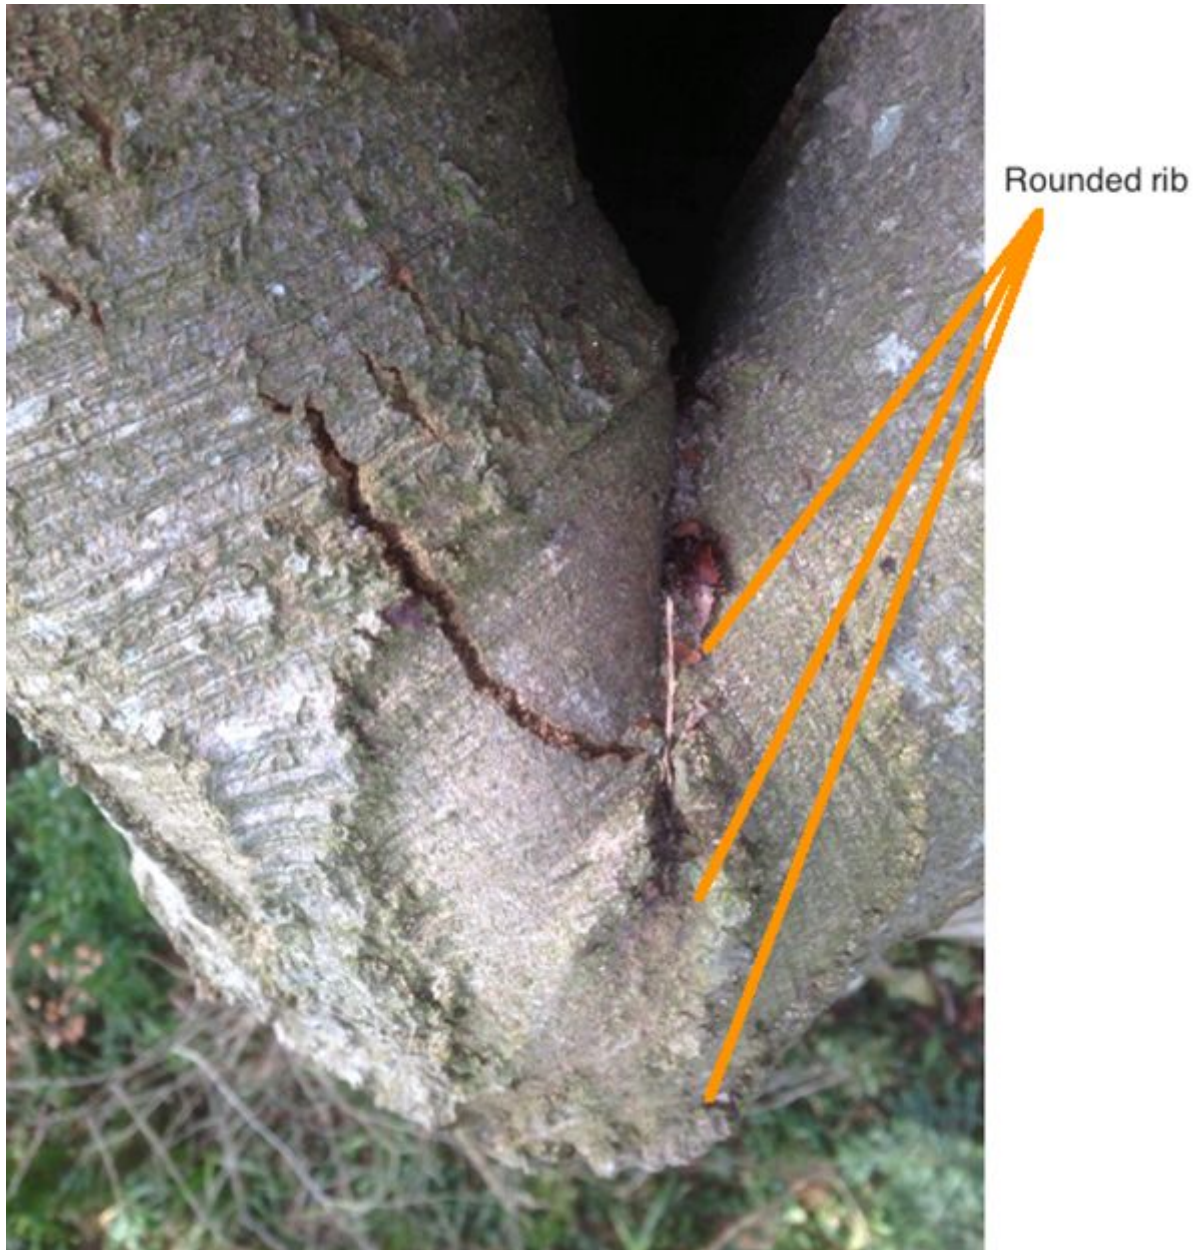
Appendix 4

- Located on the union is one pointed rib (apex 3) and another rounded rib (apex 4)
- Located on the side of the tree where the rounded rib is, of which side also holds the cracks is a sinked area of the stem (apex 5) which is a sign of minimal holding wood showing us that the cavity in-between the two stems has pockets internally within the union that are a potential weak point for the tree increasing the likelihood of failure.

Image showing rounded rib
